Regulated Building Material Survey
2135 Marvin Road N.E.
Lacey, WA 98503

Performed for:
GeoEngineers, Inc.
1101 South Fawcett Avenue, Suite 200
Tacoma, WA 98402

Date Prepared: 11/07/2012
PacRim#: 14763

Project Name / Address: Pettit Oil Site - 2135 Marvin Rd., Lacey, WA 98503

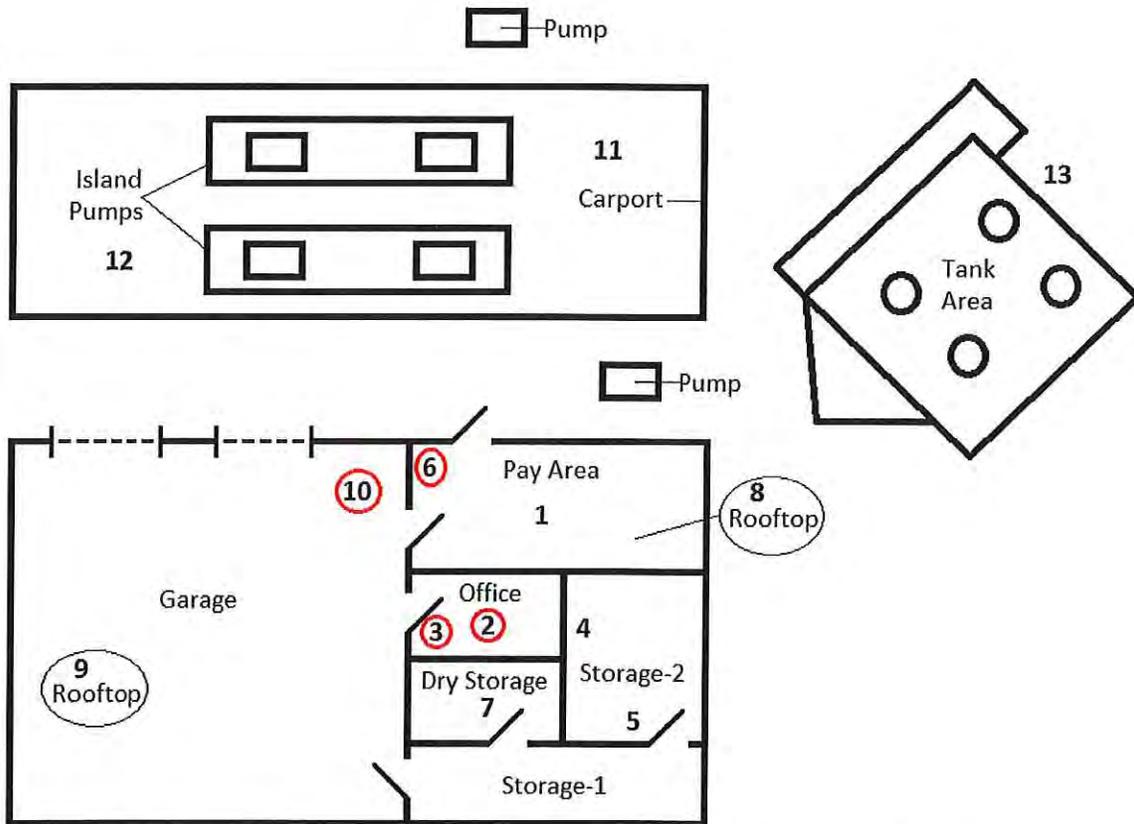
Positive samples circled in red on drawing and bold in table below.

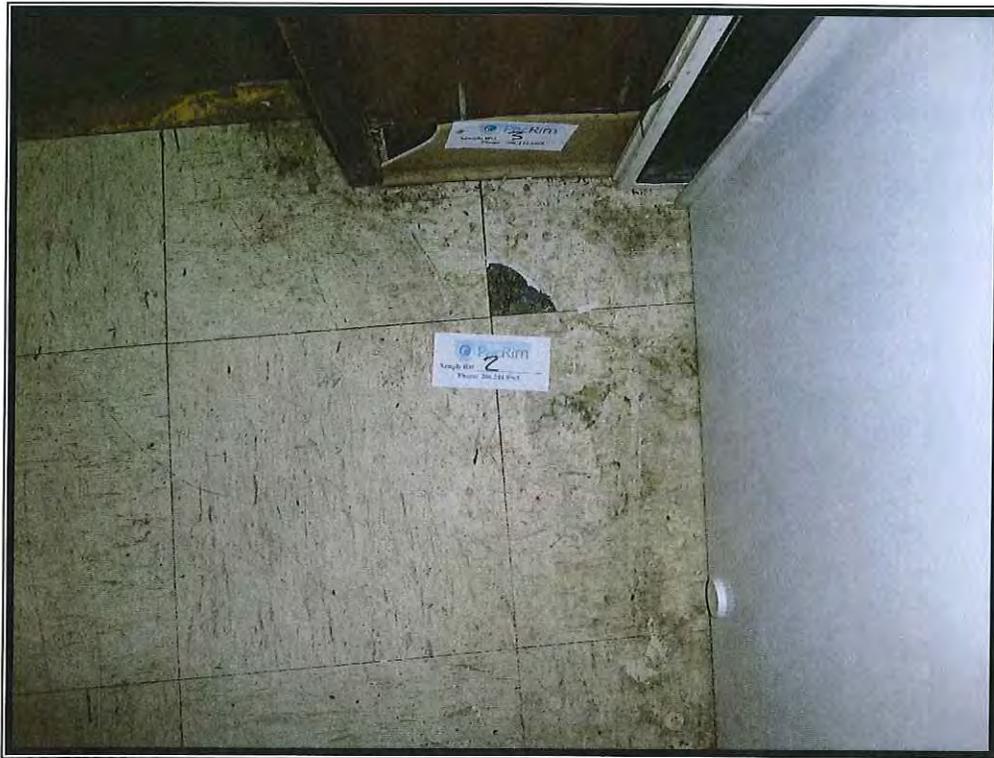
Suspect asbestos-containing **12" white tile and associated mastic** was identified on the floor in the office. The material was sampled and found to contain ***1-3% Chrysotile asbestos in the tile and 7-10% Chrysotile asbestos in the mastic***. (Sample #02)

Photo 1: Office floor, 12" white tile and mastic (Sample # 02).

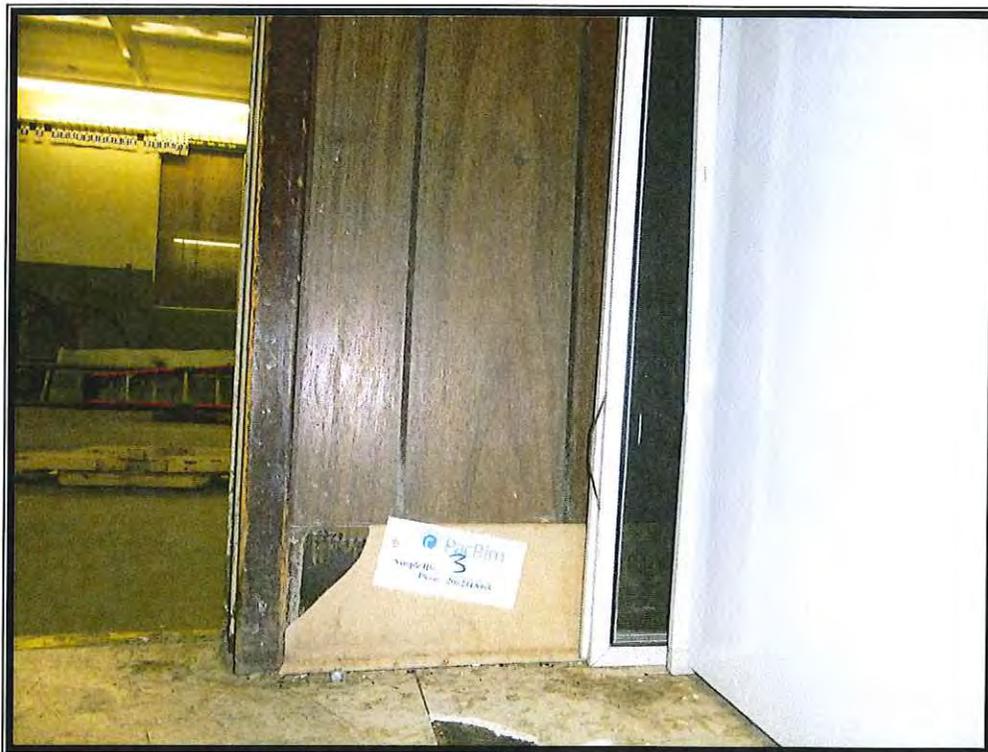
Suspect asbestos-containing **4" brown cove base** was identified on the floor in the office. The material was sampled and found to contain ***1-3% Tremolite asbestos in the mastic***. (Sample #03)

Photo 2: Office floor, 4" brown cove base (Sample # 03).

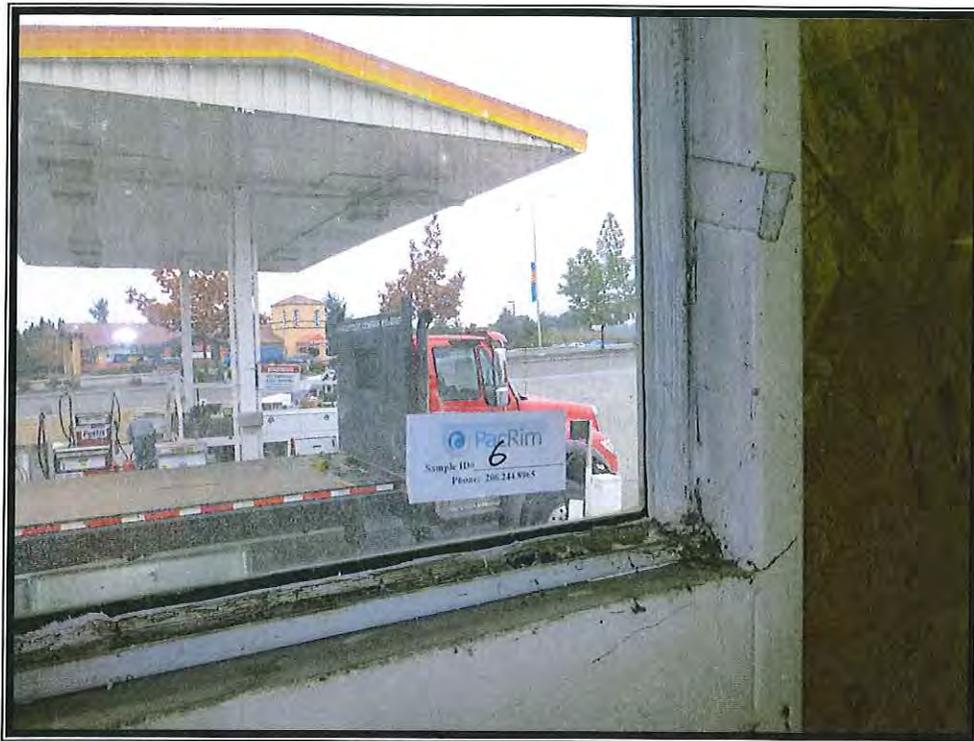
Suspect asbestos-containing **window putty** was identified on the window, top of entry door at the pay area. The material was sampled and found to contain ***1-3% Chrysotile asbestos***. (Sample # 06)

Photo 3: Pay area window at top of entry door, window putty (Sample # 06).

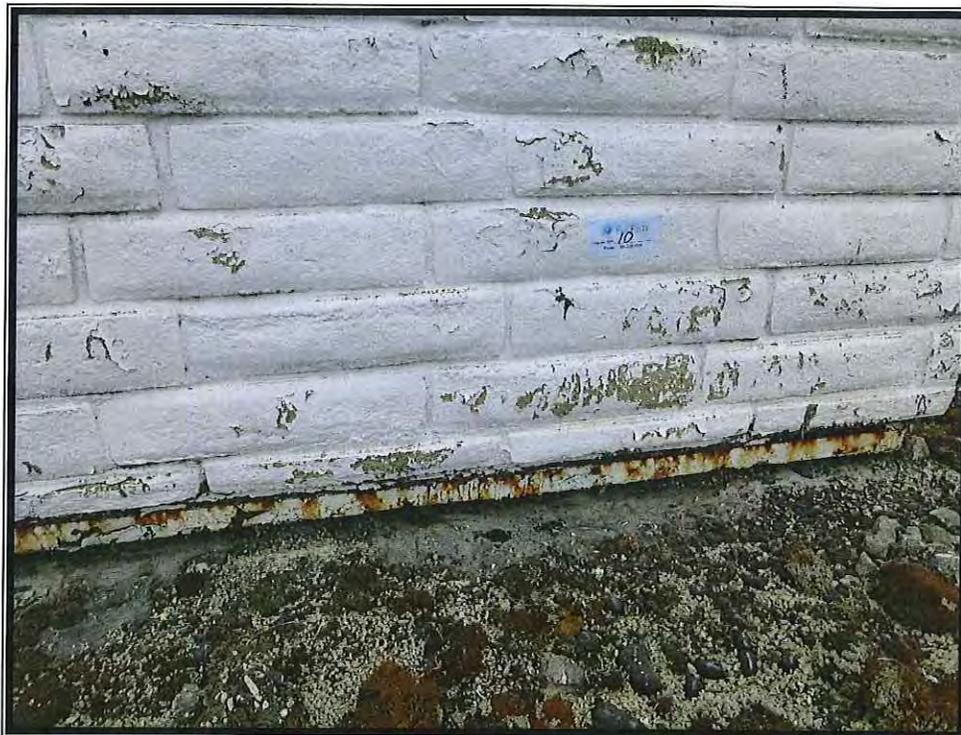
Suspect asbestos-containing **sealant** was identified on the roof, at the Chimney. The material was sampled and found to contain ***3-5% Chrysotile asbestos***. (Sample # 10)

Photo 4: Station roof at Chimney, seam sealant (Sample # 10)
